FRONTIER LAKE DAM  
WAYNE COUNTY, MISSOURI  
MISSOURI INVENTORY NO. 30007

PHASE I INSPECTION REPORT  
NATIONAL DAM SAFETY PROGRAM

PREPARED BY: ST. LOUIS DISTRICT CORPS OF ENGINEERS  
FOR: GOVERNOR OF MISSOURI

Name of Dam	Frontier Lake Dam
State Located	Missouri
County Located	Wayne County
Stream	Camp Creek
Date of Inspection	12 July 1978

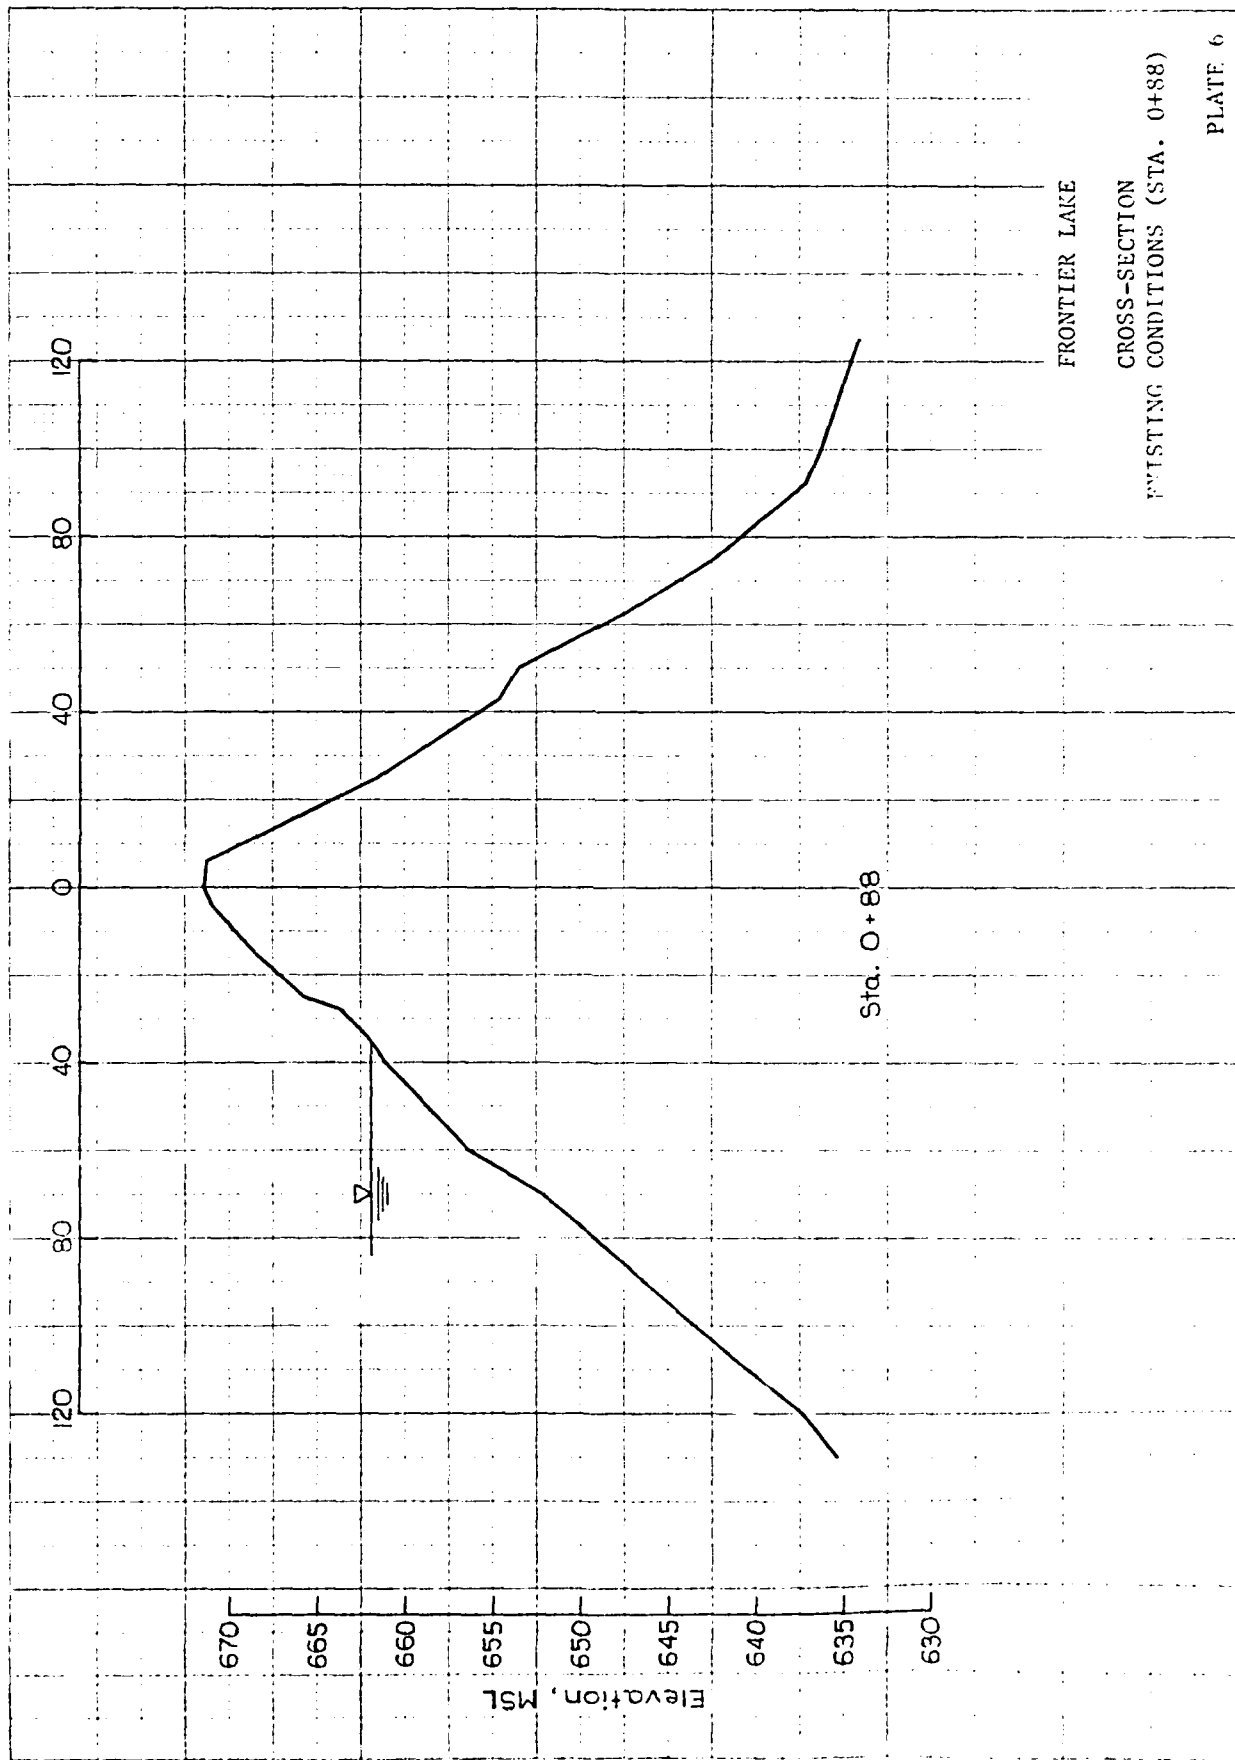
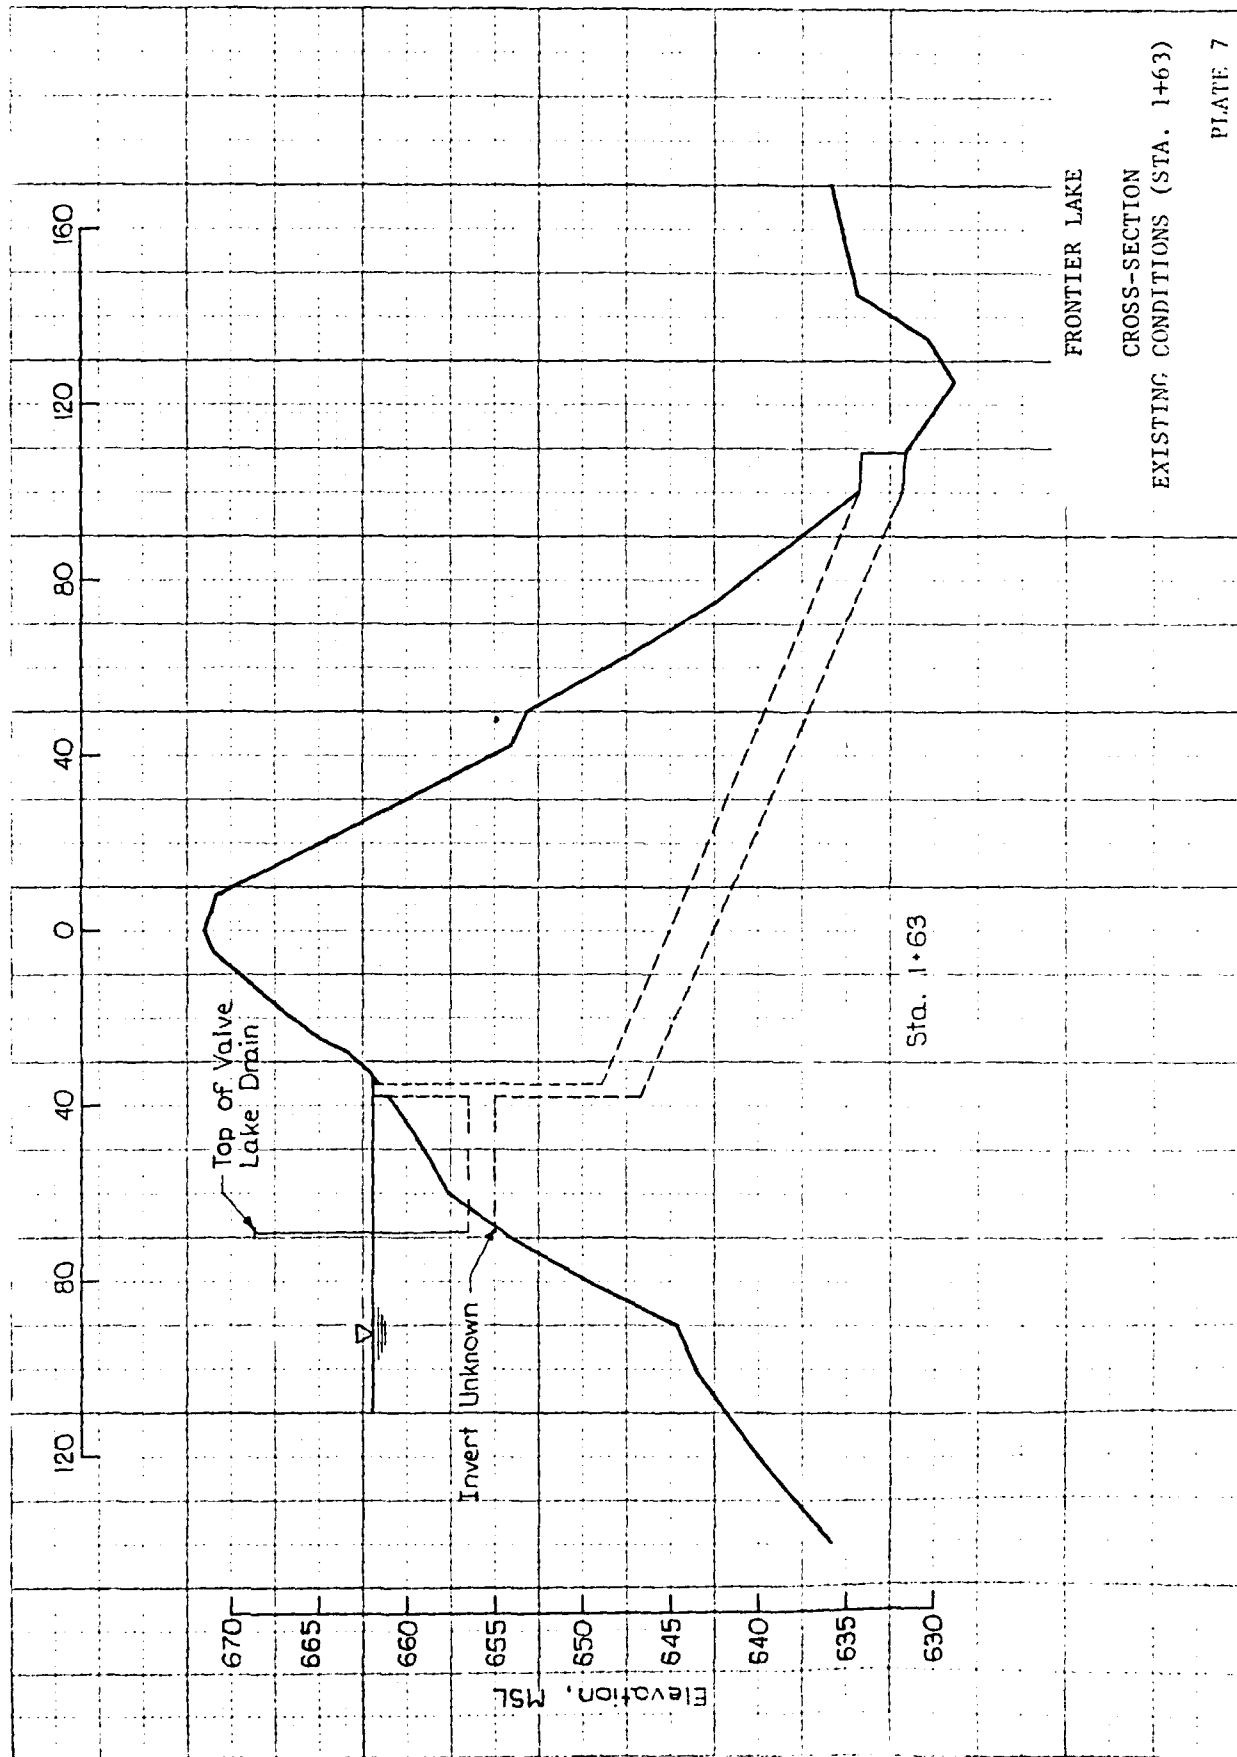
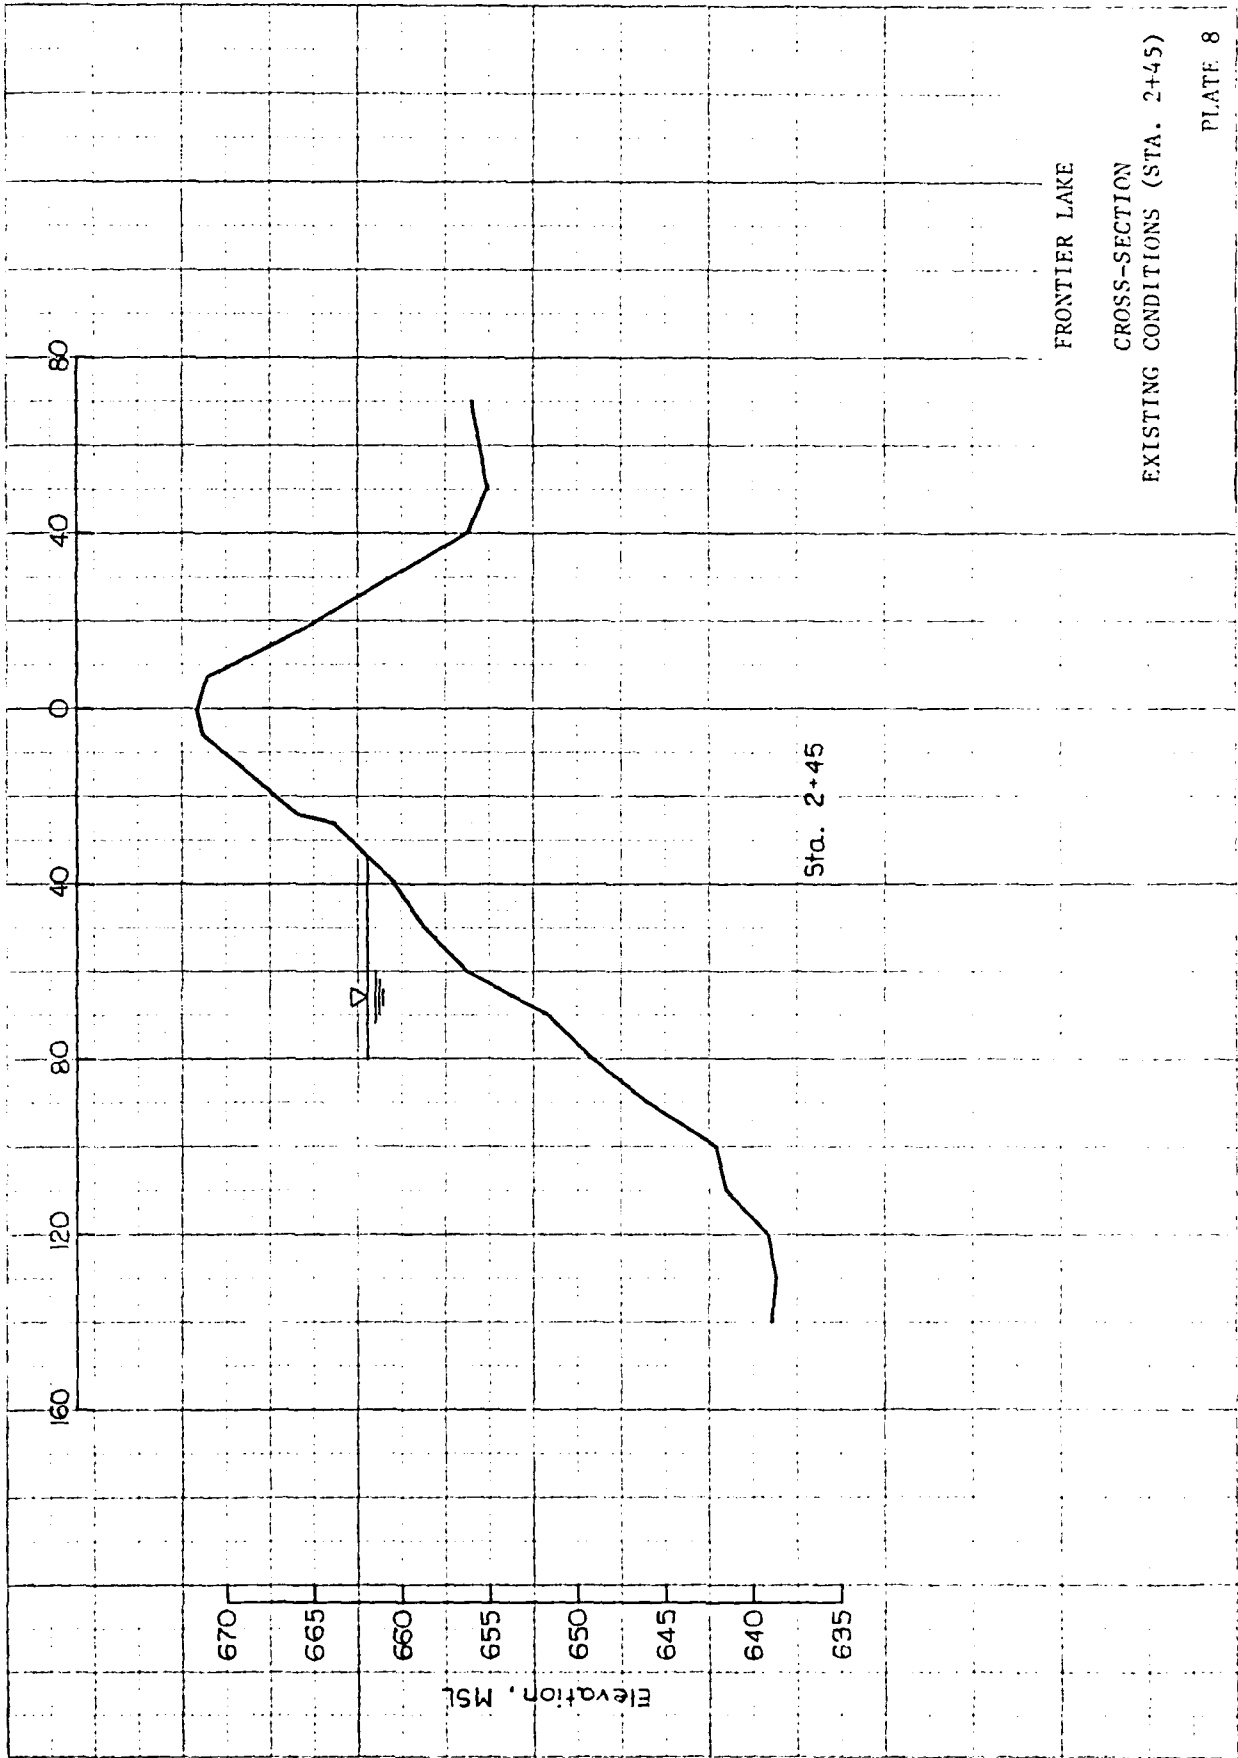
c. Dam. No detrimental settlement, cracking, slides or animal burrows were observed in or near the earth embankment. Typical existing cross-sections of the embankment are shown on Plates 6, 7, and 8. These sections are consistent with the cross-section presented in the Soil Conservation Service 1964 drawings (see Plate 5). Vertical erosion faces 2-3 feet high, were observed along the upstream embankment slope (see Photo 2). Several 5 to 8-foot high bushes and trees were growing on the downstream slope (see Photo 3).
